INVESTIGATION INTO SUITABLE SWIMMING SITES ON THE COOKS RIVER

Proposed swimming sites

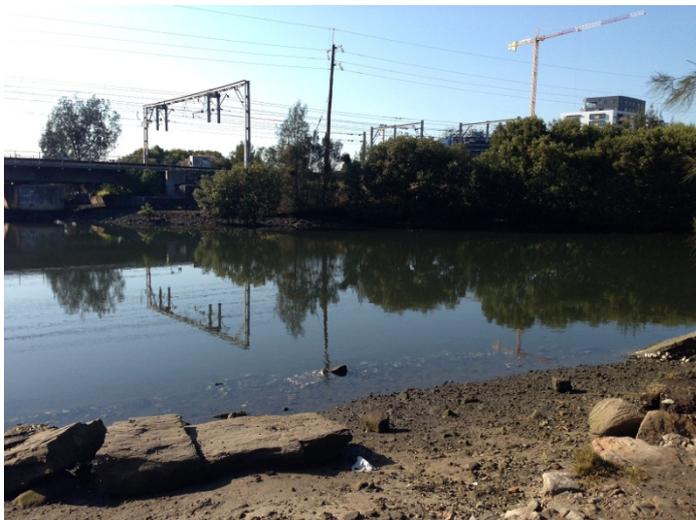
Plate1: Waterworth Park

Site	Location	Access	Facilities
1. Waterworth Park, Tempe	At the junction of Wollongong Creek and Cooks River; entry off Bayview Avenue	Open access to water but mud, rocks, slime and oysters present	No toilets in close proximity to the site
2. Kendrick Park, Marrickville	Immediately upstream of Princes Highway; entry off View Street	Good access via canoe ramp and steps	Toilets close to the site
3. Cahill Park	Entry off Gertrude St, Wollongong Creek	Narrow rocky beach with good access from park but oysters present	Toilets available in Cahill Park

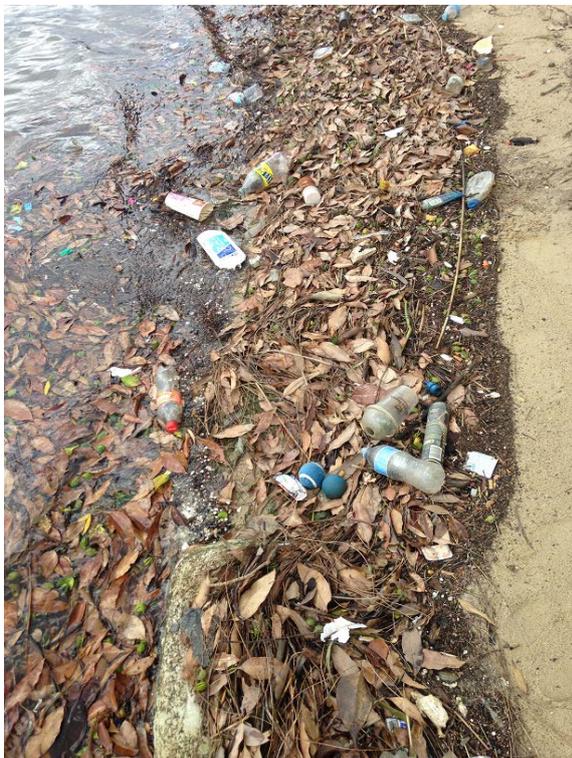
From the site visits it was apparent that physical hazards may pose a significant risk. Poor water clarity, submerged objects, oysters and strong currents, particularly after periods of heavy rain, were observed. After the rainfall lots of litter, including nappies, plastic bags and bottles, was seen floating on the river and washed up on the shoreline (Plate 4). The risk of swimmers being struck by boats must also be considered with regular boating activity taking place in the section of river near Cahill Park.

Plate 4: Litter on shoreline at Cahill Park

- provision of safe access to water (to prevent slips, trips and falls)
- presence of debris in the water such as logs, oysters and glass
- strong water currents in the lower reaches and potentially in all areas of the river following heavy rainfall
- dangerous aquatic organisms such as bull sharks
- availability of facilities for swimmers and ongoing maintenance costs
- potential risks from chemical hazards in the water and in the sediment such as heavy metals and organics.
